## Giancarlo De Carlo "Collegi" in Urbino

Published with the assistance of the Getty Foundation as a part of its Keeping It Modern initiative

## Materials and features of Modern architecture: identifying and analysing the state of repair and experimentation during restoration

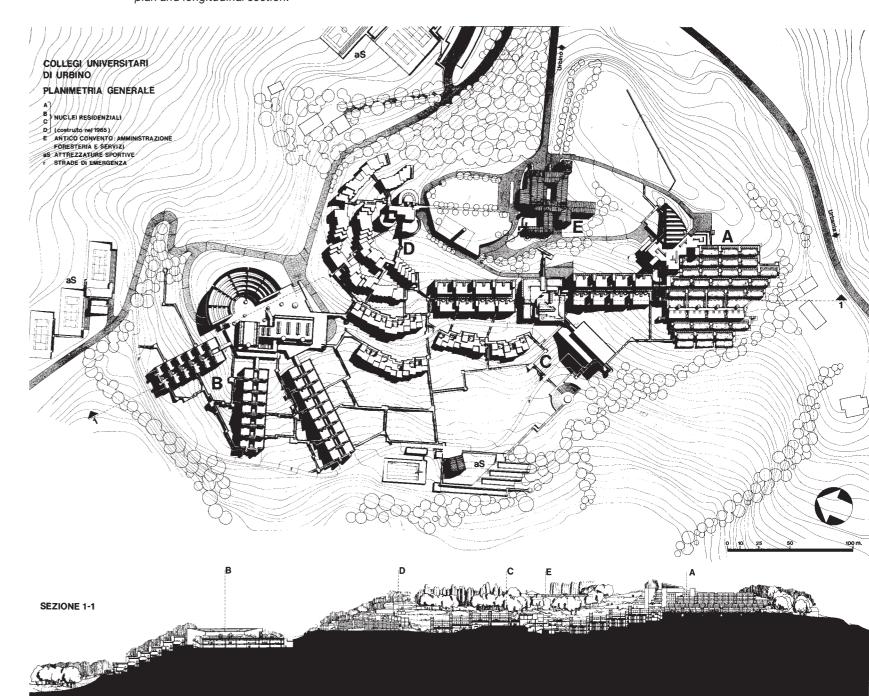
"Colle dei Cappuccini". Site plan and longitudinal section.

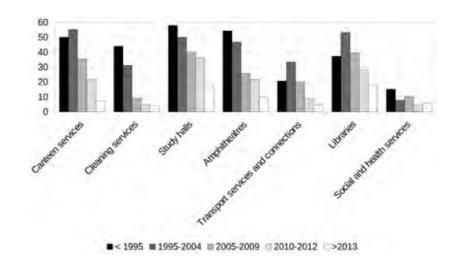
Further examples are satisfaction for maintenance, cleaning and the bar, study halls, amphitheaters and transport services (see Figure 2). For the first three items there may be an effect linked to the change and partial outsourcing of the service that matches obsolescence effects. In the case of maintenance, however, already a quarter of the early users highlighted faults, and the share of unsatisfied interviewees is stable around 60% already from the central cohort of joints since 2005.

Fig.2. Very satisfied for some aspects, facilities and services at "Collegi" for year of arrival at "Collegi" (%).

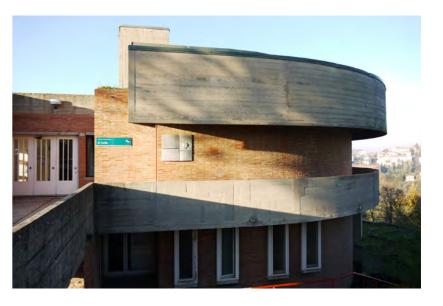
In the 90's Giancarlo De Carlo developed a model for the repairs, witch are still recognizable on the "Colle". The concrete patches has regular shape, a surface hammered and in relief. There are no technical data on that repairs, except for a letter where the name of the producer (Thoro) is mentioned.

"Colle" service building. The repair patches designed by De Carlo.

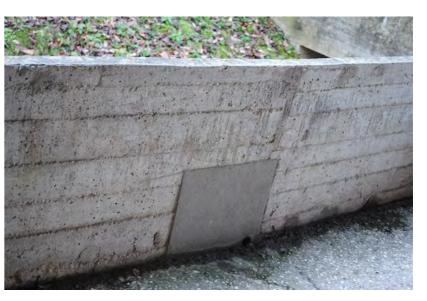
"Colle" residences. Regular repairs patches.

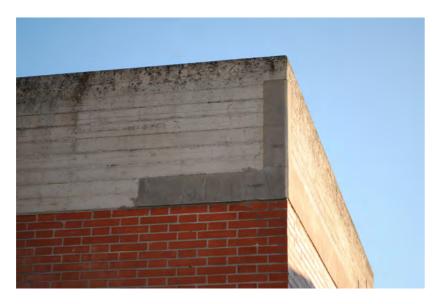
"Serpentine". Regular repairs patches.

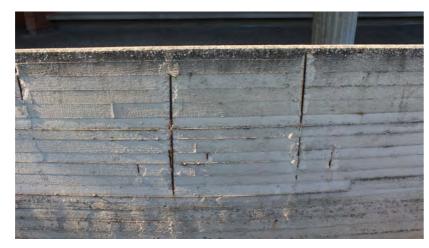
"Tridente".- Corrosion of the rebars and spalling of the concrete.

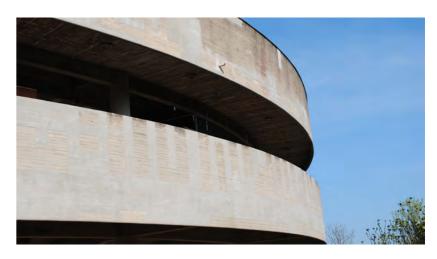
Recently, a solution inspired to the repairs developed by De Carlo has been used on large surfaces in the "Tridente", where a 2 layers commercial repair system were used. The finishing layer is very different from the original material and the regular shape of the patches, developed on a large surface, introduces a new design.

"Tridente". The repairs realized in 2016.

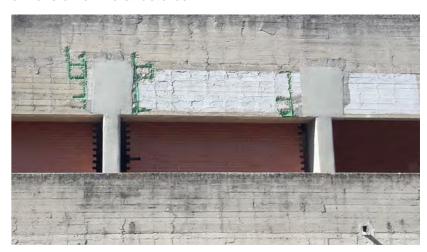
In addition, to adapt the structure to the anti-seismic regulations (in 2016, central Italy was hit by an earthquake that also involved Urbino) some of the pillars were reinforced by using fibre reinforced composite material, leading to an increase of the dimension of the structures.

"Tridente" service building. Reinforcement of the structure.

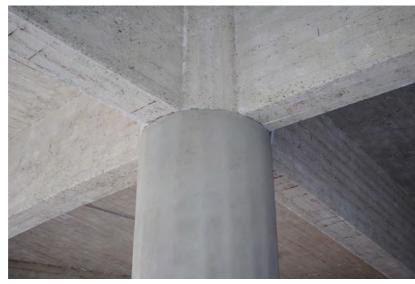
"Tridente" service building. The concrete structure, before and after the seismic retrofit.

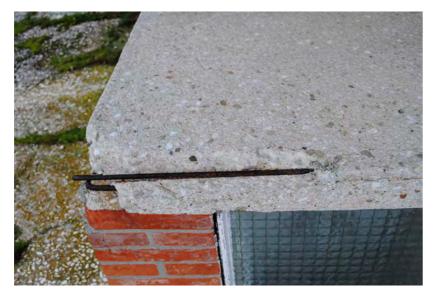
If the design – and the quality - of the concrete has huge variations, the rebars as well changes: in the first construction - "Colle" – the steel rods are smooth, whilst in the other "Collegi" the grip is improved by using corrugated bars. Only in the residences of the "Tridente", a welded steel mesh replaces the rebars; thermal expansions and the poor quality of the material has led to detachment of the outer layer.

"Colle". Smooth steel rebars.

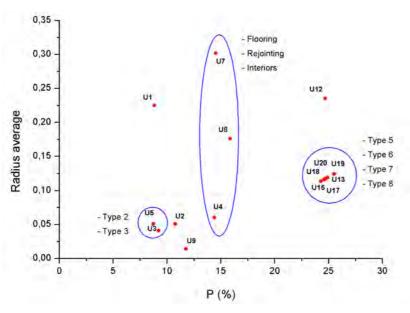
Figure 10. Classification of the samples studied in function of their porosimetric characteristics.

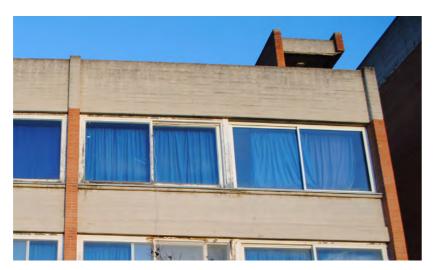
very thin (about 1 cm) and, due to the growth of the vegetation and problems of infiltration and disposal of the meteoric waters, the surfaces are wet for most of the time. In the facades of the residences of the "Aquilone" building, the trickling of the water is located where the two windows of the block are juxtaposed.

"Aquilone" residences. The trickling of the water causing oxidation and spalling at the center of the concrete slab.

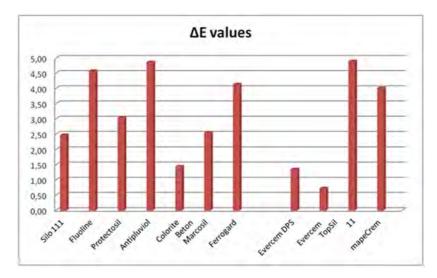
Observing Figure 2 it is possible to see that chromatic variations induced by the application of the products ranges between 0.71 and 4.88  $\Delta E$  units. References indicate that a chromatic variation detectable at the naked eye has a threshold of about 2.0-3.0  $\Delta E$  units, depending by the type of substrate. Taking this threshold into account the product 2, 4, 7, 11 and 13 have produced a colour variation over the visual damage threshold.

Fig. 2. Total Color Difference ( $\Delta E$ ) measured before and after treatments application.

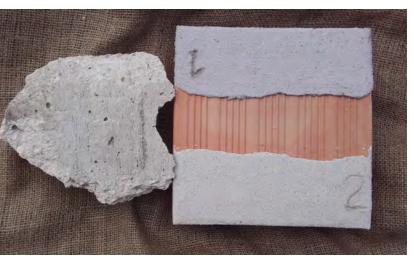
The repair mortar has been realised using a mix of white cement and local material (sand and gravel) with a binder/ aggregate ratio of 1:2 that match quite well with the surface (see the two tests in the image below). Nevertheless the different dimension of the aggregates and the texture of the surface makes the repairs immediately identifiable.

The identification of the repair mortar; two tests, compared to a sample of original material.2

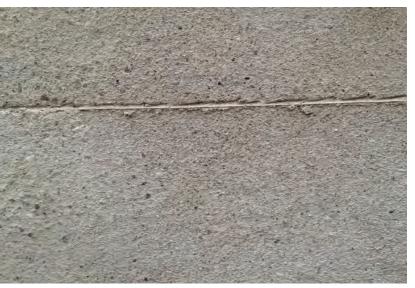
"Colle" (structure). Solid bricks (4 x 11,5 x 24,5 cm) and cement mortar (1 cm).

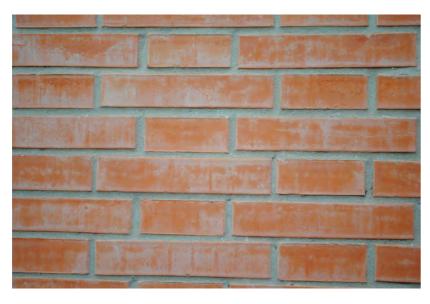
"Nuovi collegi". (structure and cladding, coupled with a concrete structure: hole bricks and cement mortar,1 cm).

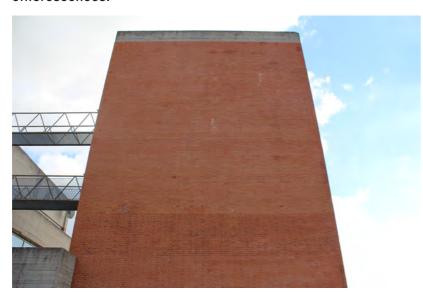
Bricks are generally in good state of conservation, except for some localized issues, as the detachment of the brick cladding from the concrete structures, cracks, due to structural problems (library and service building of the "Aquilone") and problems related to the drainage of water on the roof, that leads to infiltration between the concrete structure and the bricks, scaling and efflorescences.

"Vela". Detachment of the cladding from the concrete structure.

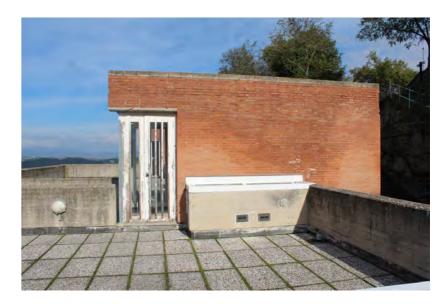
"Aquilone" residences. Stairwell, water infiltration from the skylight.

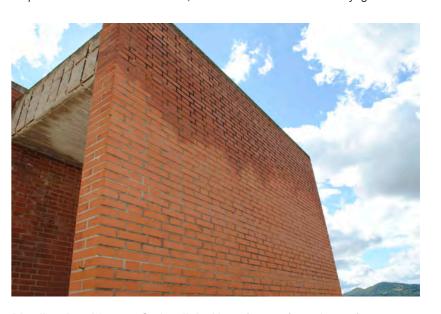
"Aquilone" residences. Stairwell, leaking of water from the roof.

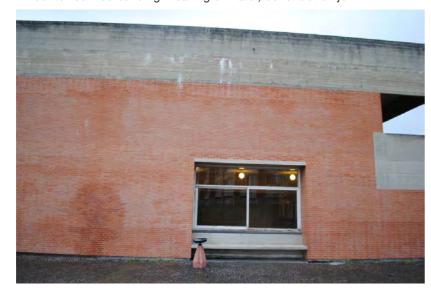
"Tridente" service building. Leaking from the internal drainpipe.

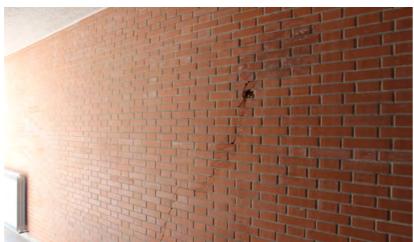
"Aquilone" service building. Cracks.

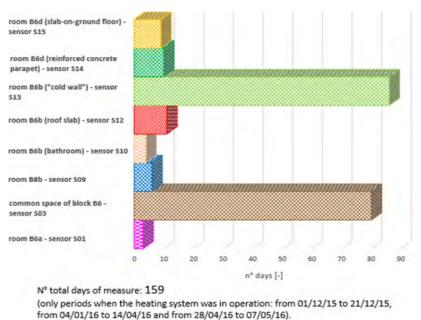
The analysis of the average daily temperature has been compared also to the average tempera-ture calculated during the heating hours, in order to verify the compliance with the temperature setpoint. An average of 20 °C in all the rooms can be observed in Fig.5. Different values have been measured by the sensors placed into the block of the common spaces and by the sensor placed close to the external wall. In 50% of cases, the temperature in the common areas remains below 20° C. Common areas are large spaces separating the rooms from the outdoor environment. They cannot benefit from free solar gains as the rooms, because they have not any large window facing South-West, nor they can benefit from thermal gains due to the presence of people, as they are usually underused. Common areas are just equipped with some radiators placed around their perimeter but, considering the huge volume to be heated, the lack of an insulated envelope and the lack of temperature control, they are not sufficient.

Figure 5. Number of days with indoor temperature < 20° C from 8 am to 10 pm.

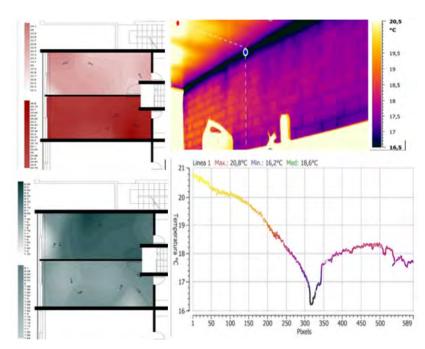
Thermography has confirmed the thermal discomfort of the outer dispersant wall, which has been discussed in the previous paragraphs. The graph in Fig.8 shows the thermal gradient between the roof slab and the dispersant wall in the points highlighted by the dotted line in the thermal image. It is possible to notice a minimum of 16.2°C in correspondence of the connection between the wall and the ceiling, with high heat losses in this thermal bridge. We can also observe a difference in temperature between the slab which is 20.8°C and the wall that is 17.5°C. These local thermal discomfort were also detected in other "Collegi", especially at "II Colle", where a surface temperature of 12°C was measured (room 83, 25 March at 10 a.m.). The psychrometric mapping on the left of Figure 8, confirms that the temperatures within the room with an outer dispersing wall are lower than those measured in an inner room. In room B6b the temperature is around 23.5°C while in room B6a is around 25.5°C. In the point of minimum air temperature, close to the "cold" wall, a maximum of specific humidity can be observed, probably caused by the evaporating effect of leaked water. The internal hygrothermal gradients are also strongly affected by the poor performance of the win-dows, which are a major issue for obtaining stable and suitable conditions.

Figure 8. Distribution of temperature (top left) and specific humidity (bottom left) in B6b room (top) and B6a (bottom) of the building "Aquilone" – 31/11/2015. Thermal image of B6b room with the thermal bridge between the wall and the roof - 01/12/2015 (right).

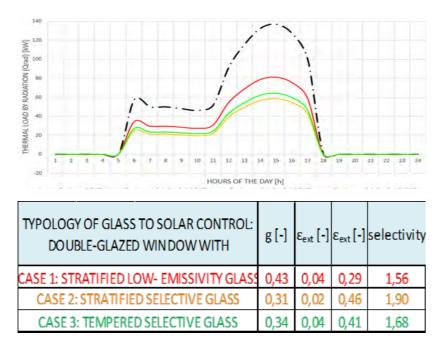
the thermal load by solar radiation is drastically reduced. This is clear when we observe the gap between the continuous colored lines (solar control glasses) and black dot-dashed line (existing glass). The reduction of the radiation heat output was evaluated considering the solar factor, the emissivity and the selectivity of three different types of solar controlled glass. Solution 1 (red curve) results in terms of thermal power by radiation, a lower reduction compared to the case 0 (black curve) because the low emissivity glass has a solar factor (g) greater than the other two cases. In addition, the low-emissivity glass of type 1 has a lower emissivity on the inner surface. This generally results in a significant reduction of magnitude if the room is air-conditioned in summer. The selective glass of type 2 (yellow curve) is the most powerful in terms of solar factor, of emissivity of the outer surface and especially in terms of selectivity. This window allows the greatest reduction of the heat load in summer conditions given that the high selectivity (1.9) allows an increased light transmittance. The solar factor is the ratio between the solar incident energy on the total glazed incoming surface. The energy expenditure of an air conditioned room can be controlled by keeping this factor as low as possible in the summer. In fact the second type has the lower solar factor (0.31).

Figure 11. Thermal load by radiation in the existing windows and after the substitution of the window glass.

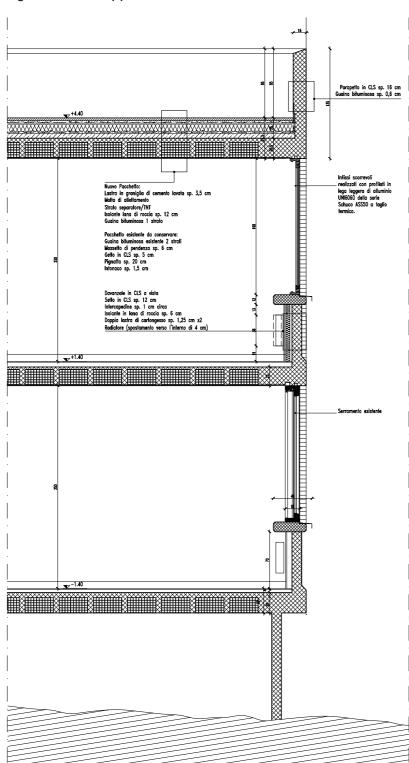
Pilot site. Drawing representing the interventions on the walls and on the terrace roof. Section.

As regards the roofs slab, different combinations were simulated to increase insulation, with tests of different materials and thicknesses, with solutions that that took into consideration the modelling and measurement data but also the various problems caused by an increased thickness of the roof and in turn an reduced height of parapets; by water collection, and by interventions that compromise the functionality of the complex. See Fig.10-11-12-13 pp.247-249.

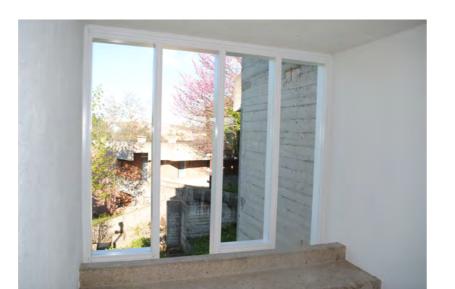
"Colle" service building. The window frames have been replaced with new elements, in wood that has the same dimension of the existing but different opening.

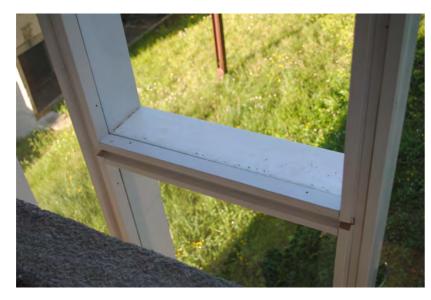
"Colle" service building. Detail of the new frames.

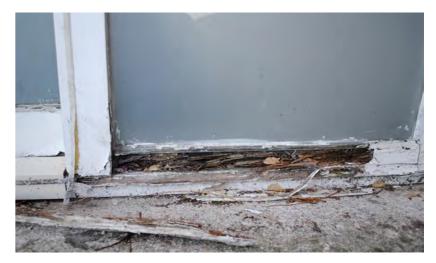
"Colle". Decay of the room's windows.
